**T-38 FORWARD WINDSHIELD DEVELOPMENT AND PERFORMANCE
DEMONSTRATION REPORT**

J. W. MYERS
PPG INDUSTRIES, INC.
AIRCRAFT PRODUCTS
P.O. BOX 2200
HUNTSVILLE, AL 35804

March 12, 1992

Final Report for period June 1982 to September 1989

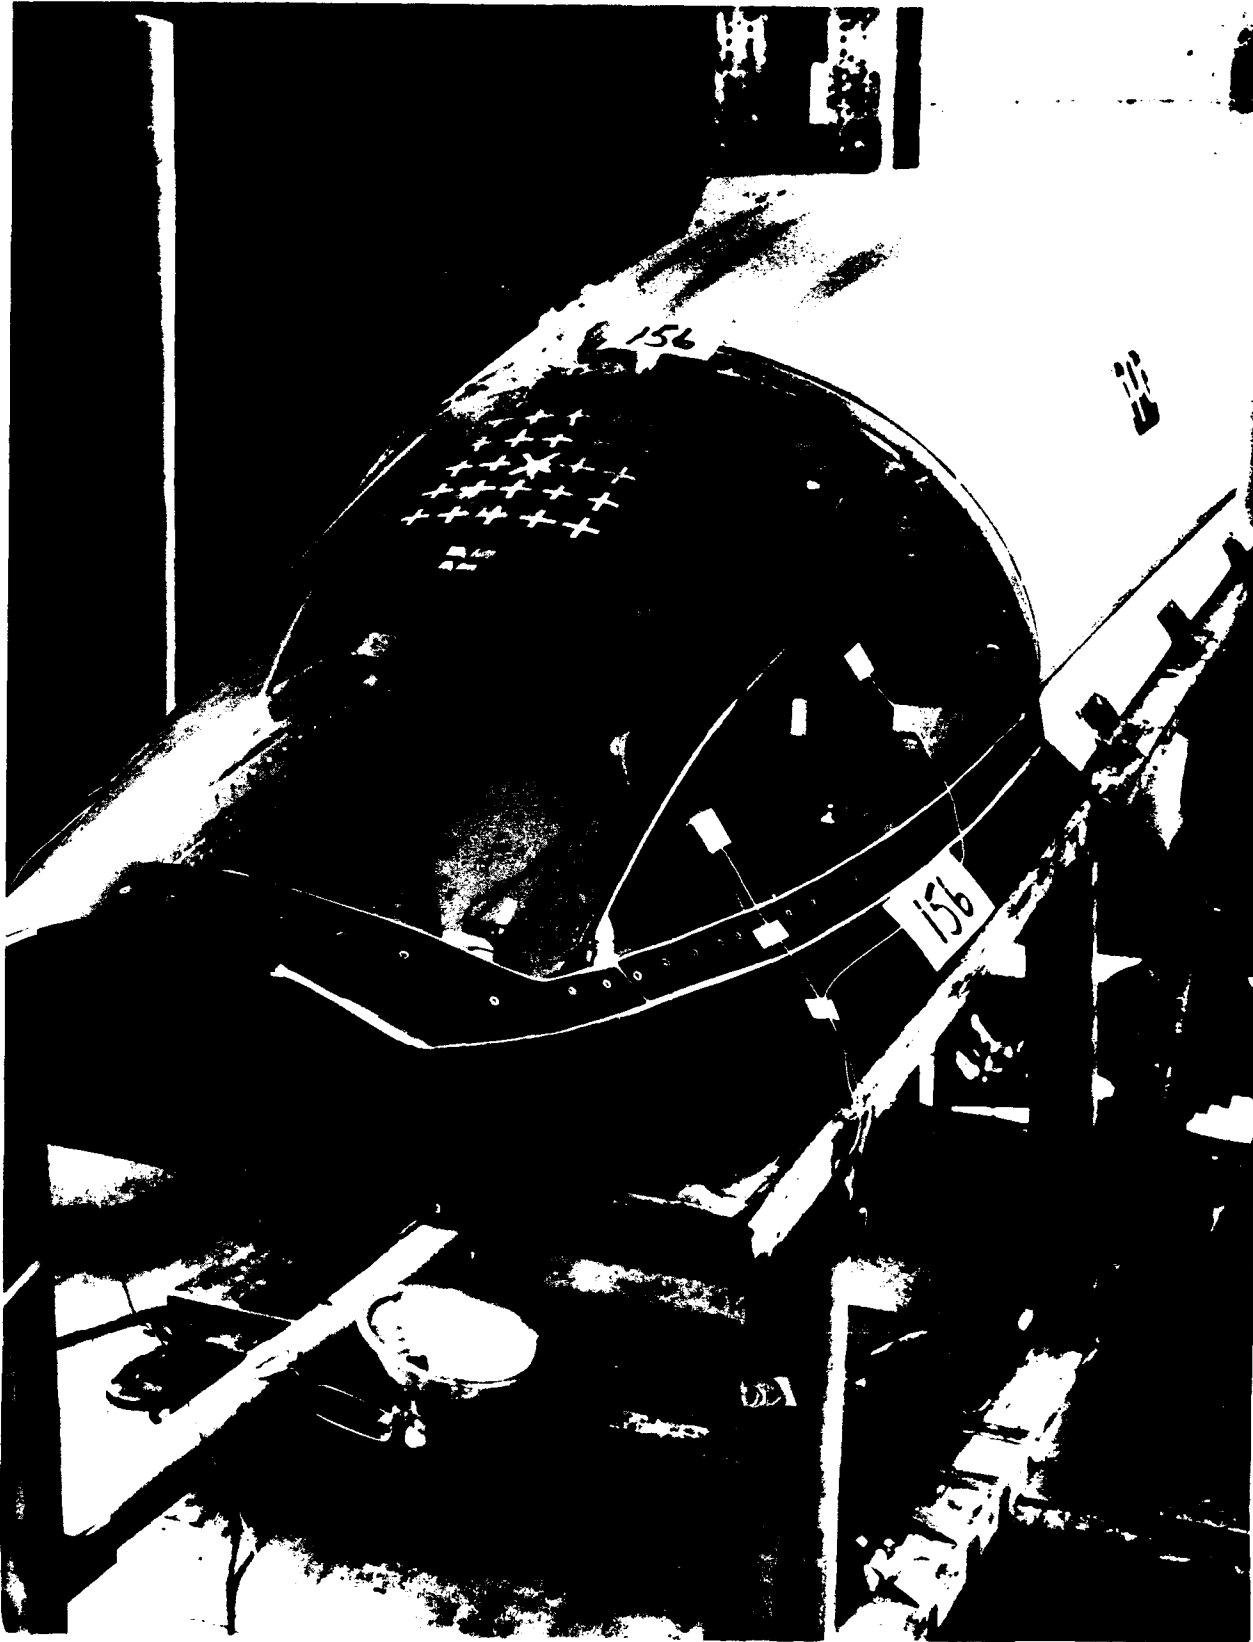
Shot #156 was 9-inches forward of aft arch on windshield center line, after a 15-minute soak period at an outboard surface temperature of approximately 210°F. Removing the electric heating blanket before impact caused the actual surface temperature reading at impact to drop to 183.7°F outboard and 162.6°F inboard. The impact produced sufficient deflection in the aft arch to allow a small amount of bird debris to enter the cockpit area and strike the witness plate.

Photograph #4. Post-Test Results
Shot #156

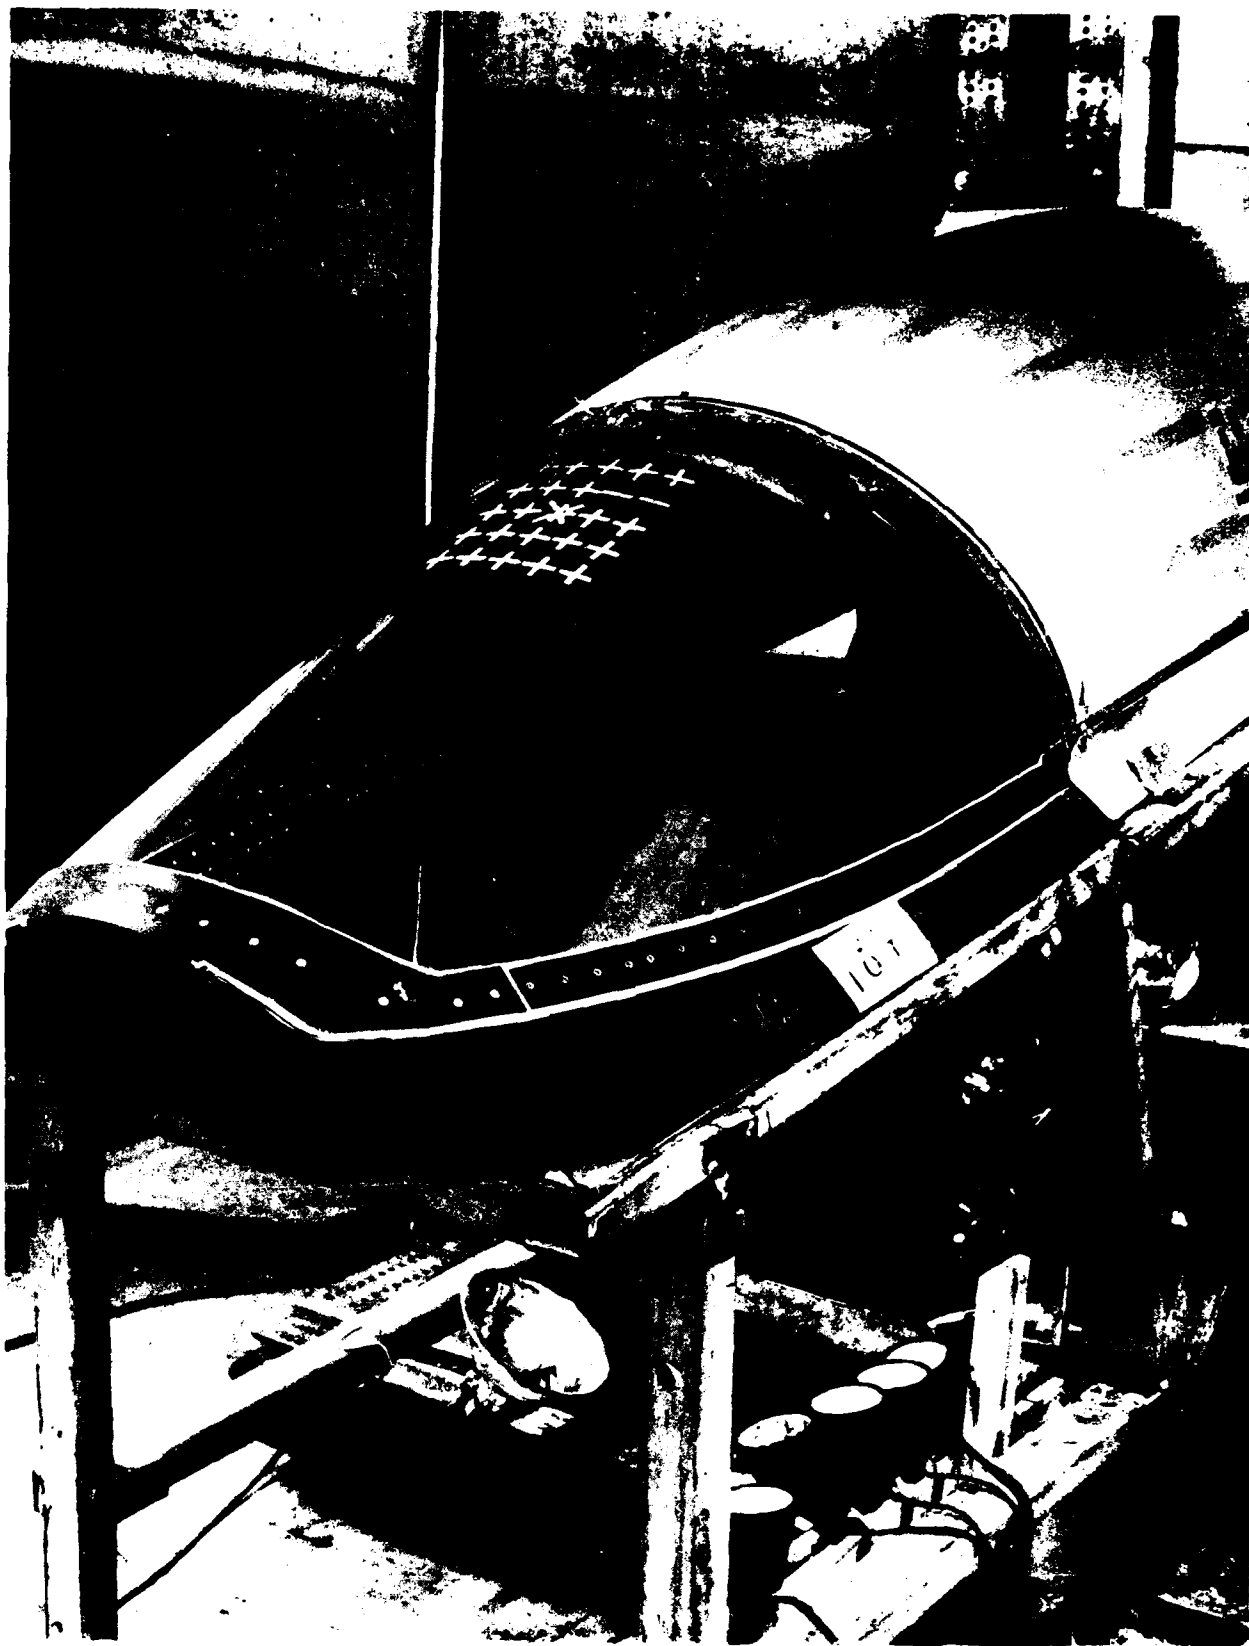
Shot #184 was 393.1-knots on windshield number 322-54, with a 4.002-pound bird at room temperature of 70°F. The window passed with no major damage, other than an approximate permanent deflection of 0.25-inch in the aft arch. Several pieces were removed from the arch material by the impact. The test also permitted a few pieces of bird residue to hit the witness plate.

PHOTOGRAPH #2
POST TEST RESULTS
SHOT #184

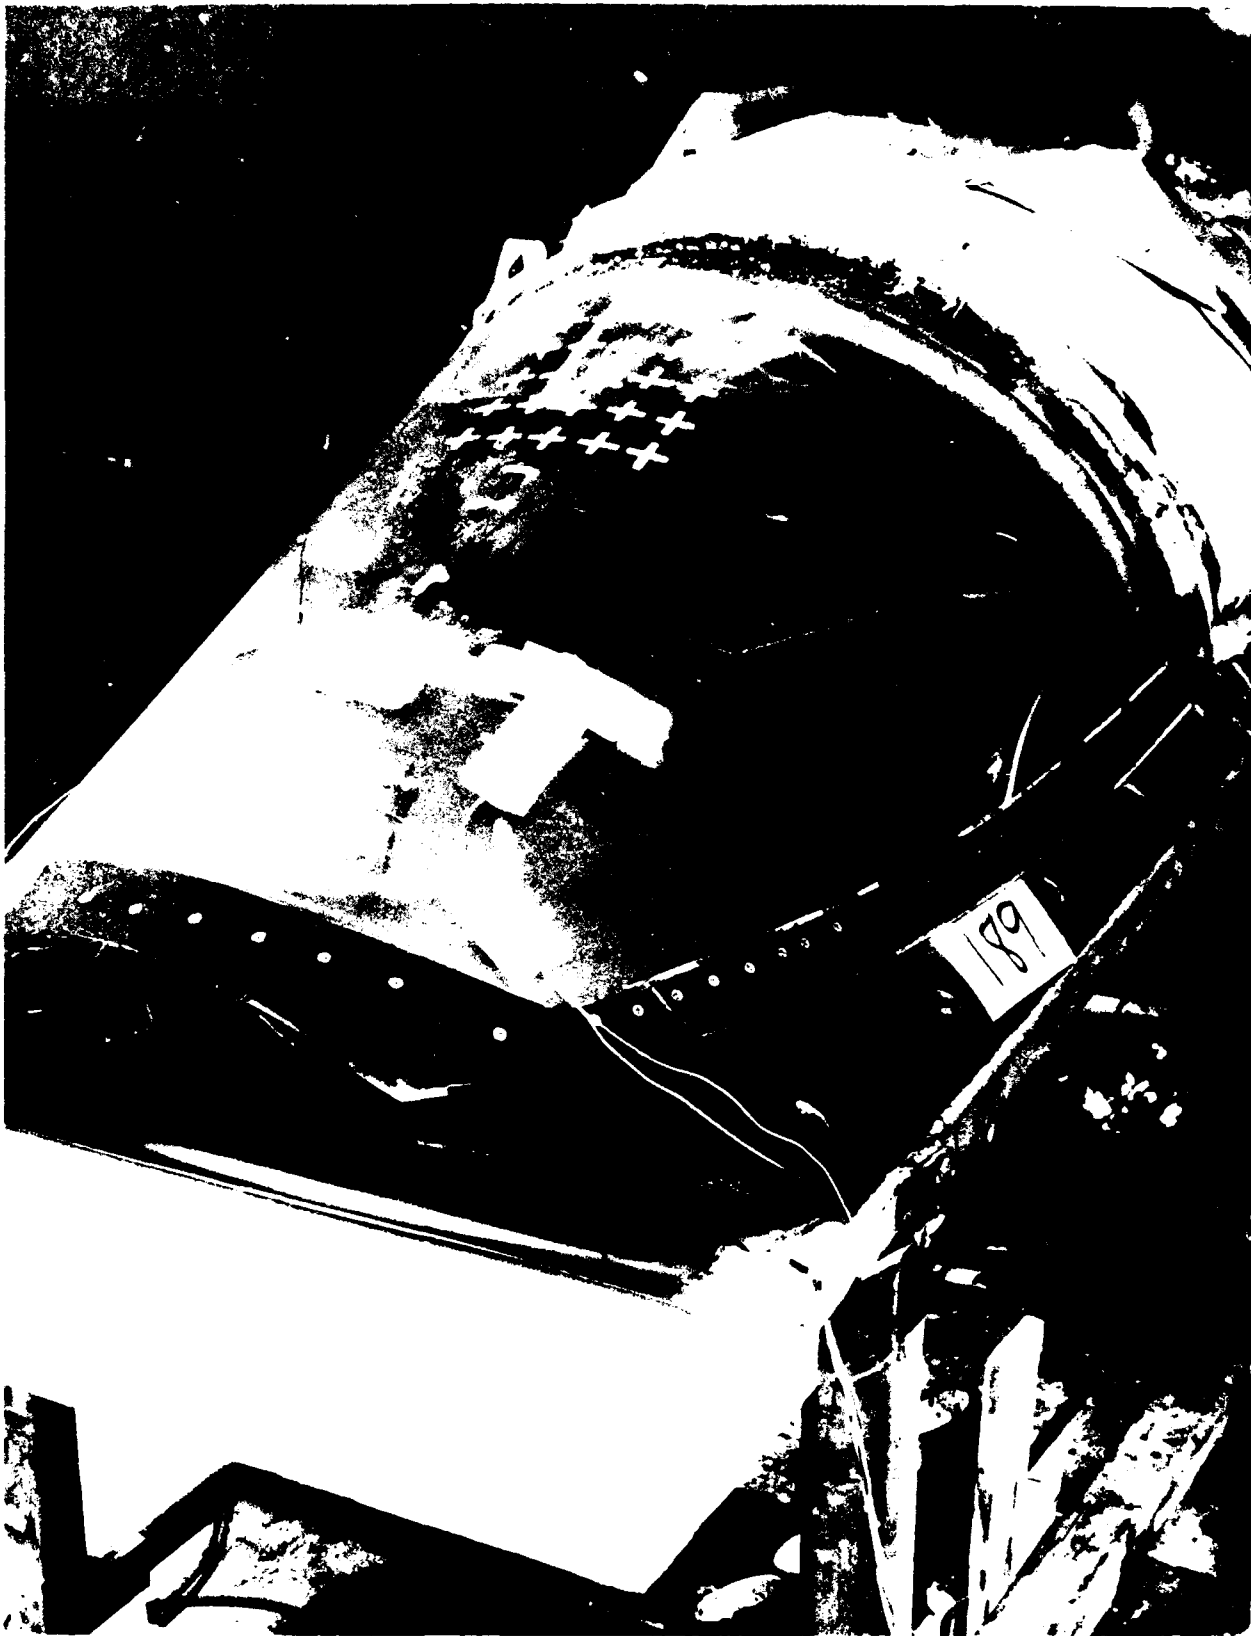
Once more, shot #189 used windshield number 322-52. Impact location was changed to the same position as used in the first three shots, 9-inches forward of the aft arch on windshield windshield center line. This test was after a 15-minute cold soak at +25°F. The impact was at 302.1-knots with a 3.998-pound bird and produced no window damage. Transparency inboard stainless steel buffer was removed before testing.

PHOTOGRAPH #7
POST TEST RESULTS
COLD SHOT #189
